ENGINEERING PROJECTS:PROGRESS REPORT

Hurricane Matthew Recovery Project

Cross Creek Bank Stabilization at Lamon Street

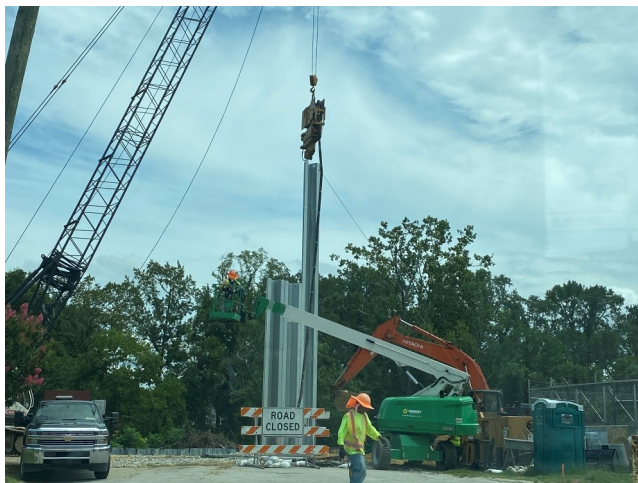
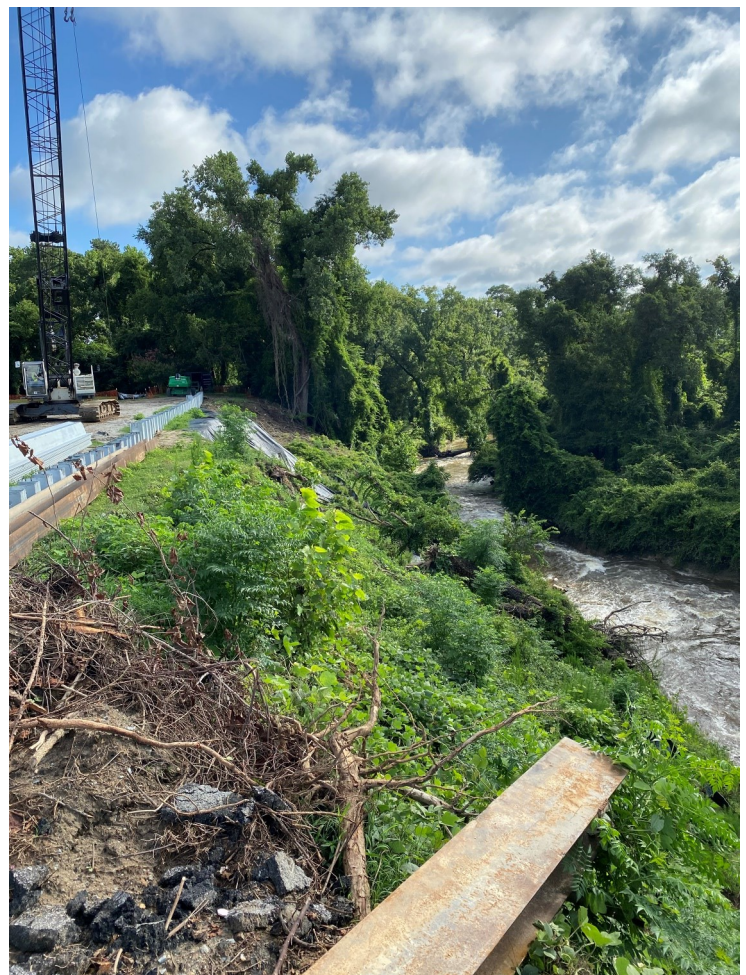
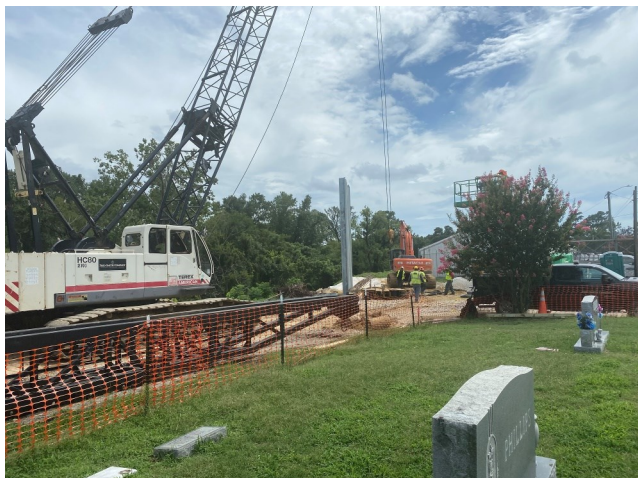
The contractor continued driving piles from Station 1+25 working towards Station 0+00. The contractor also received temporary sheeting and prepared the site for Hurricane Isaias.
